Manhole Inspection Summary

Manhole # S170__014MH

Insp Date: **3/7/08 10:59 AM**

Location Address: **2558 wilkens-alley-christian**

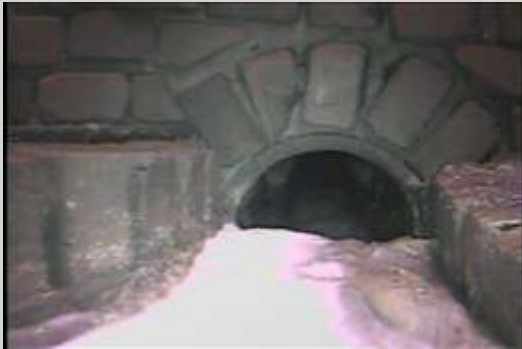
12 O'Clock Outflow

8 in. Circular Gravity Sewer
Pipe Out @ 12 O'Clock

Pipe Height: **8.4** (in.) Rod and Bar (Angled)
Pipe Material: **Clay** ☐ Pipe Lined
Invert Depth: **10.34** (ft.) Flow Characteristics: **Slow**
Deposits: ☒ None ☐ Mud ☐ Sludge ☐ Debris ☐ Grease
Silt Depth: **0** (in.) Deposits Extent:
Infiltration: **None** Pipe Seal Cond: **Sound**
